Troubleshooting guide – MES 1001

Document no.: 101457-MAN

Revision: A

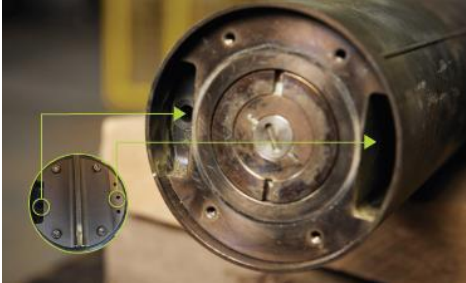
Alarm / Warning	Issue	Solution
N/A	Low or zero ppm values	<ol style="list-style-type: none"> 1. Check that the compressed air supply is open and within required range. 2. Check condition of compressed air filter units. Replace filter elements if necessary (see User Guide section 6.2.5). 3. Clean inlet and outlet holes with thin metal rod <ol style="list-style-type: none"> a. See picture below. b. See User Guide section 6.2.7 for detailed description 4. Turn off sensor and remove cabinet 5. Inspect backend for traces of exhaust gas and/or oil in compressed air system <ol style="list-style-type: none"> a. Black soot on inside of tubes b. Droplets of oil on inside of tubes c. If signs of soot or oil, compressed air system may be damaged, and repair needed. Contact Danfoss IXA Service & Support at ixa.service@danfoss.com

<p data-bbox="715 1178 1155 1211">Inlet and outlet on probe to be cleaned</p>

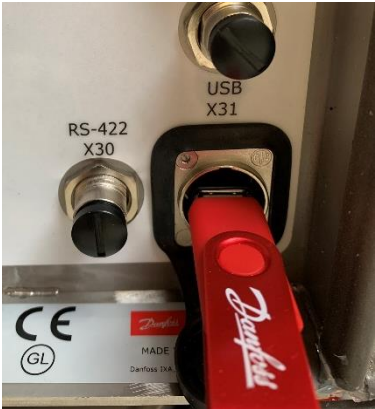
Alarm / Warning	Issue	Solution
N/A	Blank LCP / blank orange LCP	<ol style="list-style-type: none"> 1. Remove bolts in cabinet and firmly push cabinet towards probe to check if issue is caused by a loose connection. 2. If this does not solve the issue, contact Danfoss IXA Service & Support at ixa.service@danfoss.com
N/A	Erratic readings	Follow instructions for “W13: Contamination during calibration. Check air supply.” in this troubleshooting guide.
N/A	No signal on SCR panel	The analog outputs on MES 1001 requires 24 VDC supply. Check the loop power for analog outputs and/or refer to User Guide section 6.3.3 for guidance.
N/A	<p>USB error message on LCP: “Storage media not found”</p> <p>(For example, during SW update or download of Diagnostics Report.)</p>	<p>Check that</p> <ol style="list-style-type: none"> 1. USB is correctly inserted in USB connector on front panel (see picture below) 2. All files from the installer zip-file are unpacked and copied to the root of the USB drive 3. USB capacity is not larger than 32 GB (sensor only supports USB drives up to 32 GB size). 4. USB is formatted to use FAT32 file system 5. If still not working, try using a different USB drive. <p>NB! It is recommended to start out with a new/blank USB drive</p> <p>See User Guide section 2.4</p>

<p>USB drive connected at interface panel</p>
